DEPARTMENT OF TRANSPORTATION

Contract #: 04-0120F4Cty: SF/ALA Rte: 80 PM: 13.2/13.9File #: 99.28**WELDING INSPECTION REPORT****Resident Engineer:**Siegenthaler, Peter**Address:** 333 Burma Road**City:** Oakland, CA 94607**Report No:** WIR-016568**Date Inspected:** 04-Sep-2010**Project Name:** SAS Superstructure**OSM Arrival Time:** 700**Prime Contractor:** American Bridge/Fluor Enterprises, a JV**OSM Departure Time:** 1900**Contractor:** Zhenhua Port Machinery Company, Ltd (ZPMC)**Location:** Shanghai, China

Orthotropic Box Girder (OBG) at Trial Assembly Areas

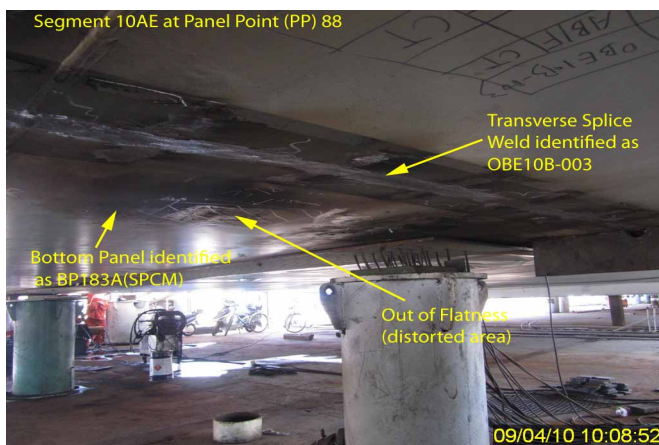
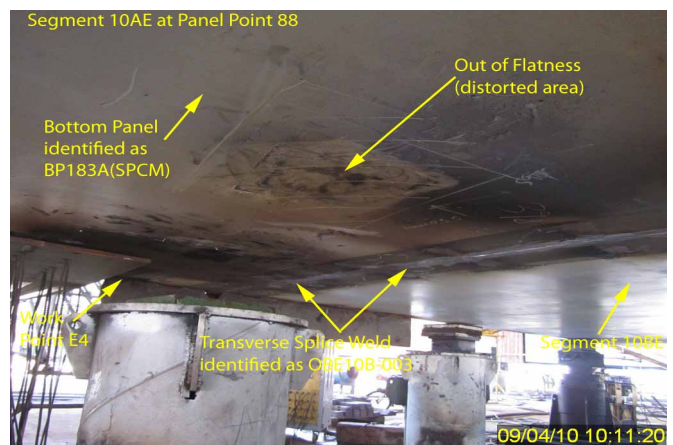
This Quality Assurance (QA) Inspector wrote an Incident Report for out of flatness issue which was visually observed at Bottom Panel for Segment 10AE at Panel Point (PP) 88 and between PP 85.25 to PP 86 at E4 location. Please reference the Incident Report # 04-0120F4_TL-15_B278_09-04-10_10AE_Out_of_Flatness_Bottom Panel_PP88 and PP85.25 to PP 86 dated September 04, 2010 for further detail.
